## Damage Growth Studies on Composite Flap Structures Under Fatigue Loading

V Sessa Kumar\*, HV Ramachandra, B Varughese, KM Gaddikeri,  
Ramesh Sundaram and M.Subba Rao

Advanced Composites Division, National Aerospace Laboratories, Bangalore 560 017

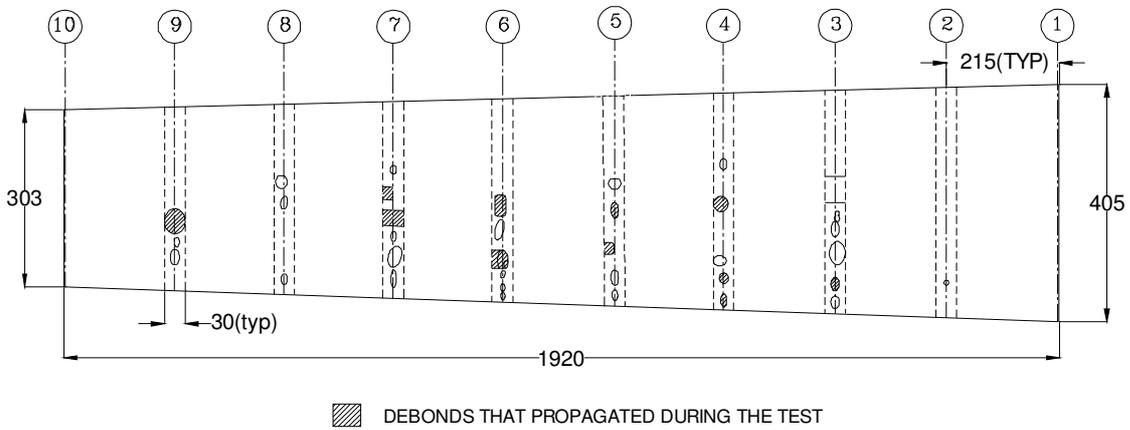
The outboard flap of SARAS aircraft is a cambered aerofoil manufactured using carbon/ epoxy prepreg manufactured by Ms.Hexcel Composites. The flap structure is divided into a nose box and an aft box. The aft box is a cobonded construction with 8 chordwise I-section ribs bonded to the skins using Redux 319A film adhesive. The root rib, tip rib and the spar are mechanically fastened to the aft box. The nose ribs are mechanically fastened to the nose skin. An exploded view of the flap is shown in Figure 1. After curing, debonds between the top skin and rib interface were noticed at many places. Most of the debonds were of half width of the bonded flange area and lie on one side of the rib web as shown in Figure 2. The bottom skin and rib interface did not have any debonds.

Fig. 2. Debonds in the rib-top skin interface of aft box of outboard flap before test.

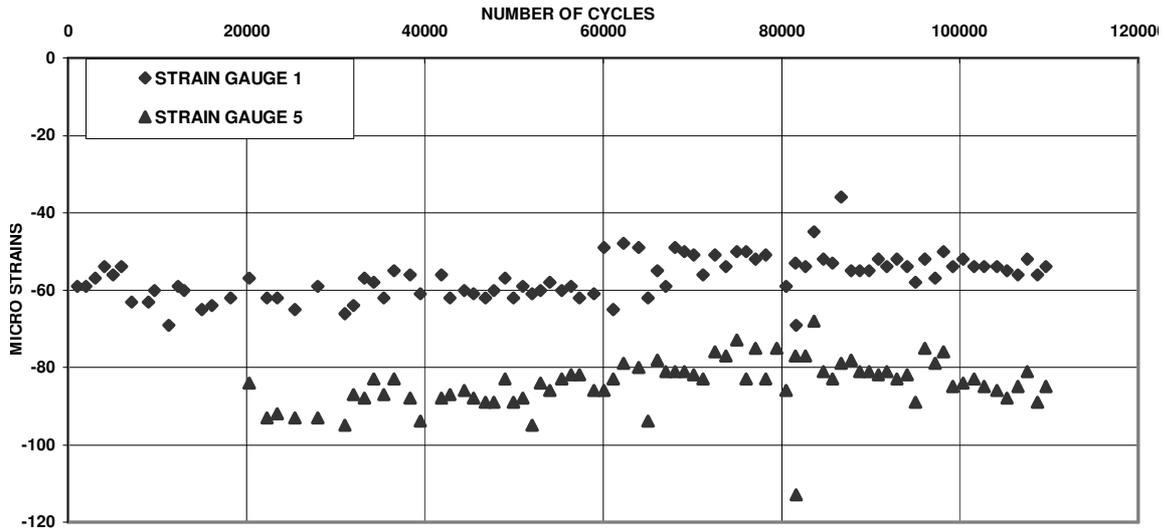
The debonds in the skin and rib interface did not show any growth till 25000 load cycles after which their growth initiated slowly at various locations as indicated by the ultrasonic A-Scan between few cycle blocks. However it was found that the growth of debonds at a given location was found to be intermittent and not a continuous phenomenon. Different debonds had grown by different magnitudes in different cycle blocks. This may be due to the variation in the quality of bond, which is assumed to be uniform. Figure 9 shows the strain plot of gauges 1 and 5 which were mounted on the debonds. Significant changes in the strain levels could not be seen though these debonds had grown slightly during the test. Figure 10 shows the strain plot of strain gauges 13 and 18 which were mounted on a good region closer to the debonds. The strains in these gauges did not change in spite of some growth. The low growth of debonds was attributed to the low level of strains in the structure since the flap design is driven by stiffness considerations.

Fig.9. Strain data on debonded regions

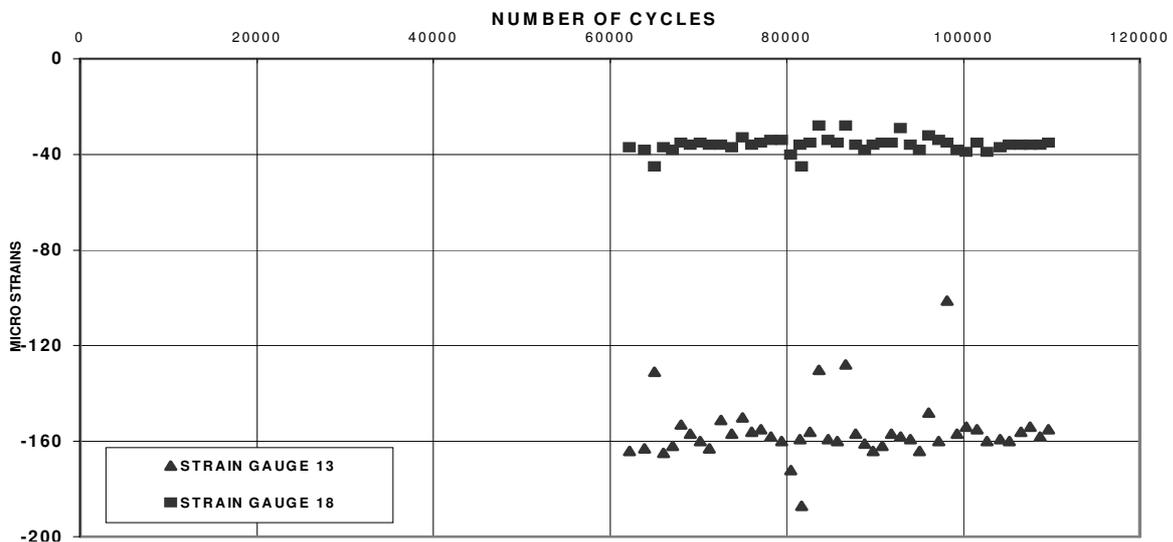
Fig.10. Strain data on healthy regions

As there was no appreciable change in the strains, it was concluded that the structural integrity of the flap is intact after 110000 cycles of limit load. The small amount of growth in debonds was not enough to cause the loss of stiffness of the structure which is vindicated by the strain data. This was also corroborated by the dial gauge data to monitor the maximum deflection of the structure. The deflection of 10mm under limit load at the start of the cycling was increased by 1mm at the end of the cycling. The increase in deflection is not significant to conclude that there was a stiffness loss in the structure.

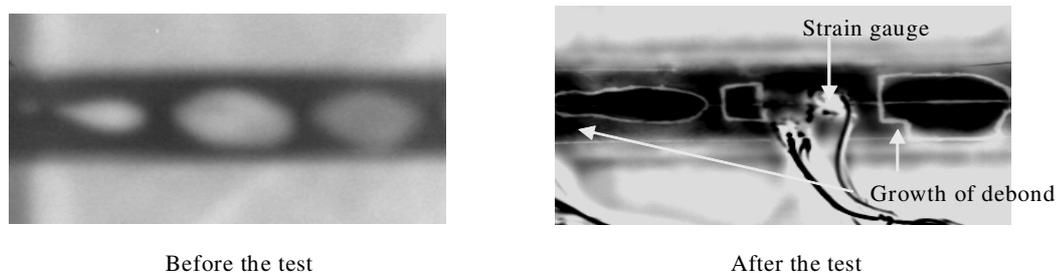
The infrared thermography images were taken at each rib before the start and end of fatigue cycling. Figure 11 shows thermography images for the rib 3 before and after the test. The thermography report at each rib was in good agreement with the ultrasonic A-scan report. The acoustic emission sensors continuously monitored the test and the results are presented in a companion paper<sup>8</sup>.

Fig.11. Infrared thermography of rib no. 3
